## **Use of In-Situ Metallography for Plant Health Assessment Studies and Failure Investigations**

Paresh U. Haribhakti  
TCR Arabia LLC  
Kingdom of Saudi Arabia  
Email: [paresh@tcr-arabia.com](mailto:paresh@tcr-arabia.com)

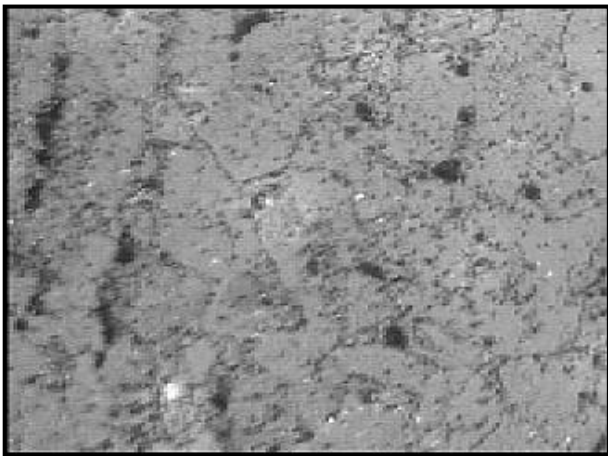
**Figure 3** – Shows the Replicated Microstructure of Spheroidized Structure of SA 335 P11 Material, Exposed in the Service for 15 Years (400X)

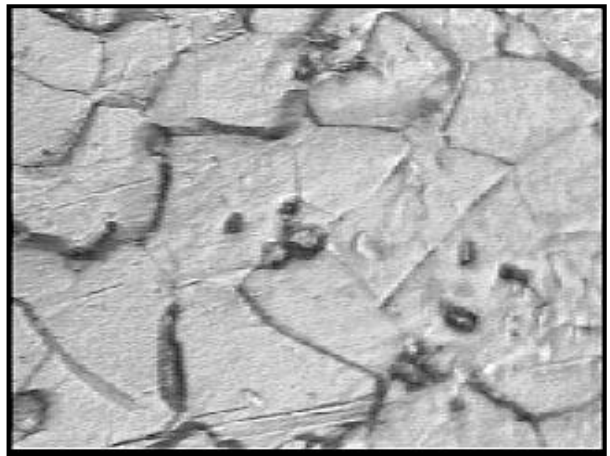
**Figure 4** – Shows Microstructure of Plain Carbon Steel Material Showing the Grain Boundary Oxidation, Exposed to an Accidental Fire (400X)

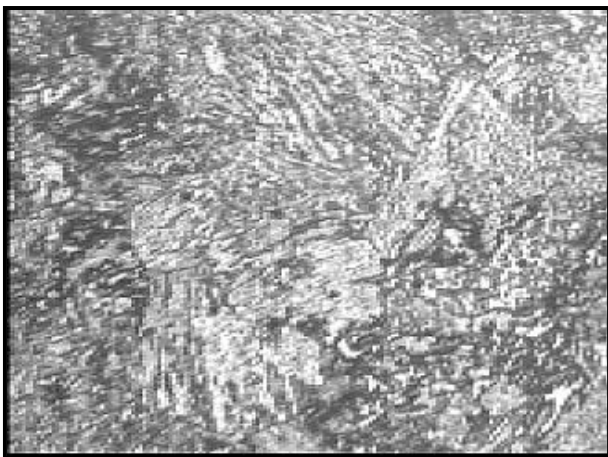
**Figure 5** – Replicated Microstructure of Cr-Mo-V, HP Rotor Shaft Showing Bainitic Structure and Prior-Austenitic Grain Boundary (100X)

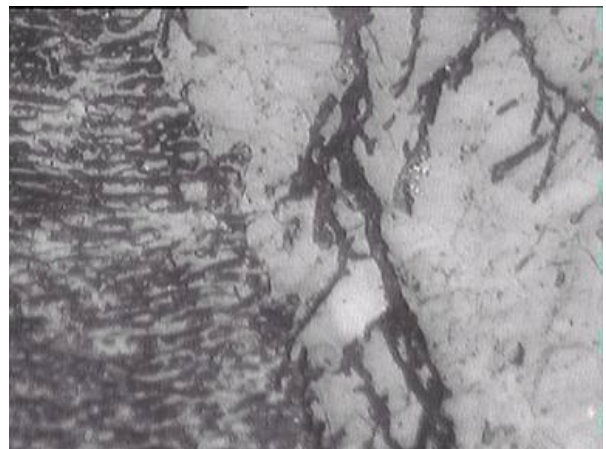
**Figure 6** – Replicated Microstructure of 304 SS Reactor Showing Trans Granular Stress Corrosion Damage at HAZ (400X)

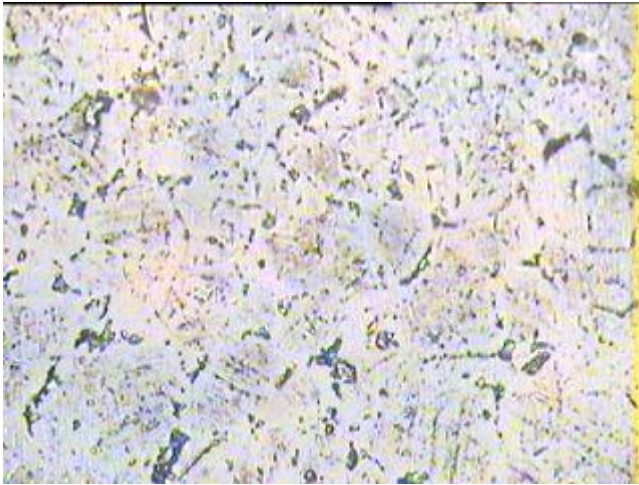
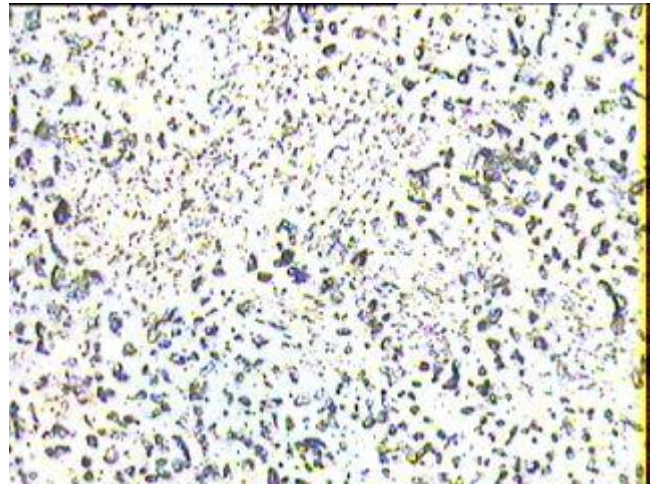
Stainless steels are normally used in refineries in the range of service temperature where they are susceptible to sigma phase formation. Normally, the temperature ranges between 580-960°C. Corrosion resistance is drastically reduced and its formation leads to brittle failure of the components during start up and shut down of the plant. In-situ metallography is effectively used to find out presence of sigma phase with electrolytic etching. If it is finely distributed spread uniformly in the microstructure, then it is less harmful. However, if sigma phase is concentrated in form of lumps it is highly detrimental – more so when inter connected. During shut downs, it can trigger onset of corrosion finally leading to leakage. The percentage of sigma phase can be calculated using automatic image analyzer software that aids in taking a decision whether the component is to be replaced or used further. Figures 6 & 7 show the microstructures indicating copious sigma phase formation after 8 years of service of SS 304H pipe in FCC service of refinery. 15-20% of sigma in the weld metal was judged as the criteria that increases the susceptibility towards cracking. However, the decision of replacement depends on the morphology of the sigma phase and cracking tendency of the weld.

Figures 6 & 7 are microstructures of SS 304H material showing presence of sigma phase formation at the grain boundaries and within the grains of parent metal and at inter-dendrite regions of weld metal.

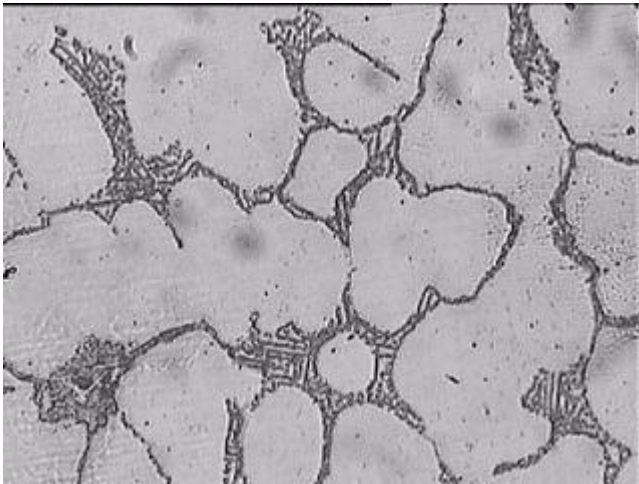
**Figure 8 – Microstructure of HP Modified Alloy**  
Shows Inter-Dendritic Network of Primary Carbides in the Matrix of Austenite. Presence or Secondary Precipitations including Carbides are Observed within the Matrix (400X).

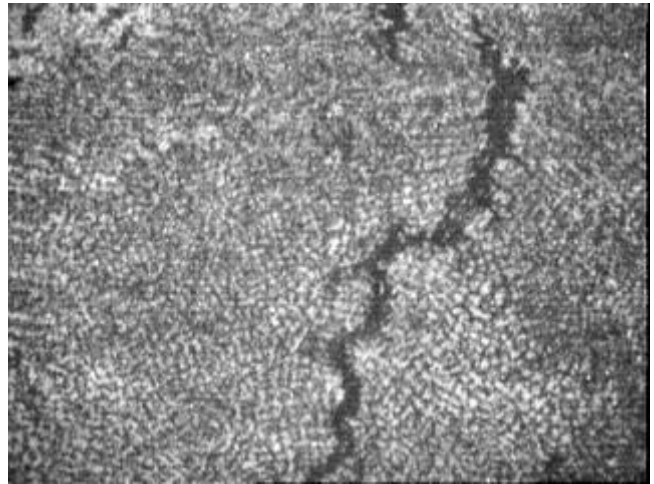
Reformer tubes are used in fertilizer industries, refineries and petrochemical industries either for hydrogen generation or reforming of hydrogen along with the steam. The tubes act as individual reactors for the reforming process. The specific failure mechanism involves creep generated mid wall fissures that progress towards the OD. Mid wall fissures that were noticed under conventional NDT test like UT, Radiography and Creep determination by OD measurements with judicious approach. In-situ metallography was used to determine whether the tubes can be used further or be retired immediately. Figures 8 & 9 are the selected microstructures of in-situ metallographs from a reformer tube of HP modified alloy; comparing control virgin tube microstructure versus the presence of micro cracks in a

used tube having 12 years of service completed. This indicated the final stage of creep life and the tube was retired from the service in order to avoid failures during service.

**Figure 9 – Microstructure of HP Modified Alloy**  
Shows Primary and Secondary Precipitates including Carbides. Coarsening of Secondary Precipitation Observed within the Austenitic Matrix. Micro Cracks are Observed. Carbides Present at Dendritic Regions (100X).

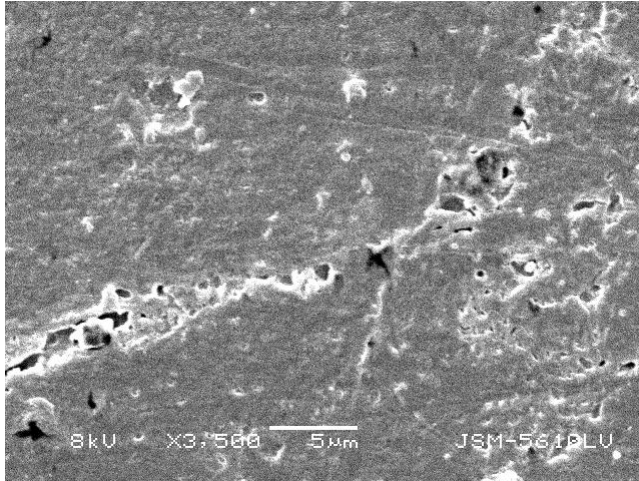
**Figure 10** – SEM Picture of Parent Metal of Microstructure of P11 Material Showing Oriented Creep Cavities at Grain Boundaries (X3500)

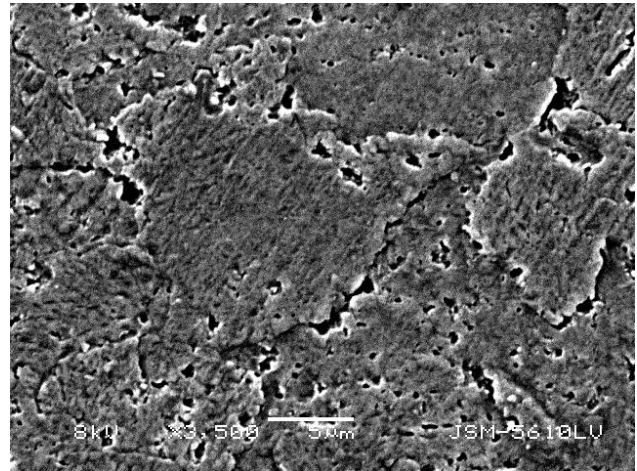
Boiler pressure parts like super heater tubes, steam pipes and headers are operating in the creep range and they are designed for certain minimum lifetime. These components deteriorate continuously during the service, as a result of time dependent material degradation process like creep, fatigue, corrosion and oxidation. The limiting factors for the components operating at high temperature and pressure are creep life. Creep life is considered exhausted when it reaches the macro cracks through cavitation stage. The damage takes place in four successive stages formation of cavities, alignment of creep cavities, micro cracks and macro cracks. One can find out the life fraction consumed by identifying the prevailing stage in the microstructure. The successive stages are no creep cavities, isolated creep cavities, oriented creep cavities and the final stage of micro-cracks. Next monitoring interval is based on the level of degradation observed. Observing under SEM after gold sputtering can have most reliable judgments. Figures 10 & 11 are SEM micrographs of the main steam line showing oriented creep cavities with initial stage of micro cracks. It was recommended to monitor the cracks after one year through in-situ metallography and start planning for the replacement in next two years.

**Figure11** – Microstructure of P11 Material Shows Initial Stage of Crack Formation at the Grain Boundaries (3500X)

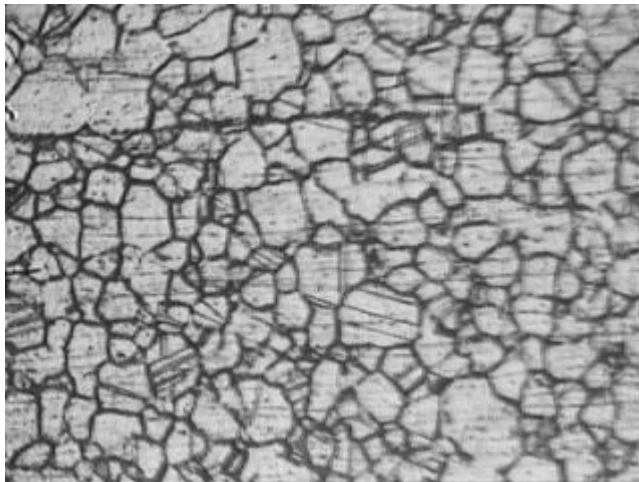
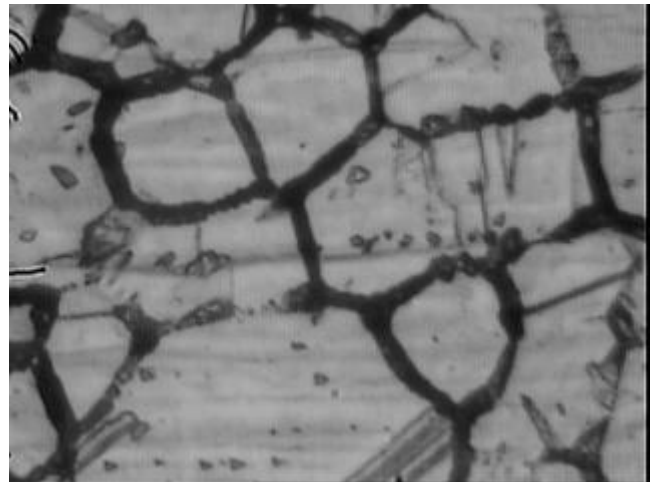
Figures 12 and 13 shows sensitized microstructure of Type 316 stainless steel indicating heavy carbide precipitation at the austenite grain boundaries.
