# Replica Microstructures -Guidelines

REFINERIES | CHEMICAL | FERTILIZERS | PETROCHEMICAL | OIL & GAS | POWER

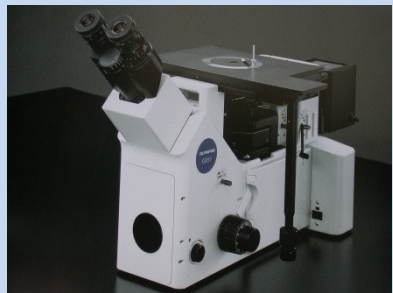
Optical Microscopy

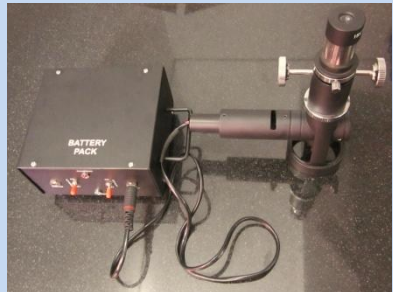
Portable Microscope

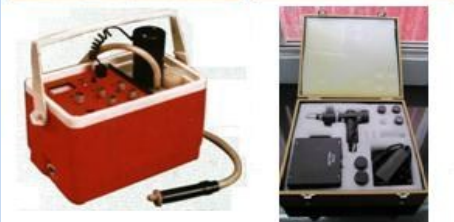
In-situ Metallography by replication method.
