# Reformer Tube Inspection and Remaining Life Assessment as per API 579-1/ASME FFS-1

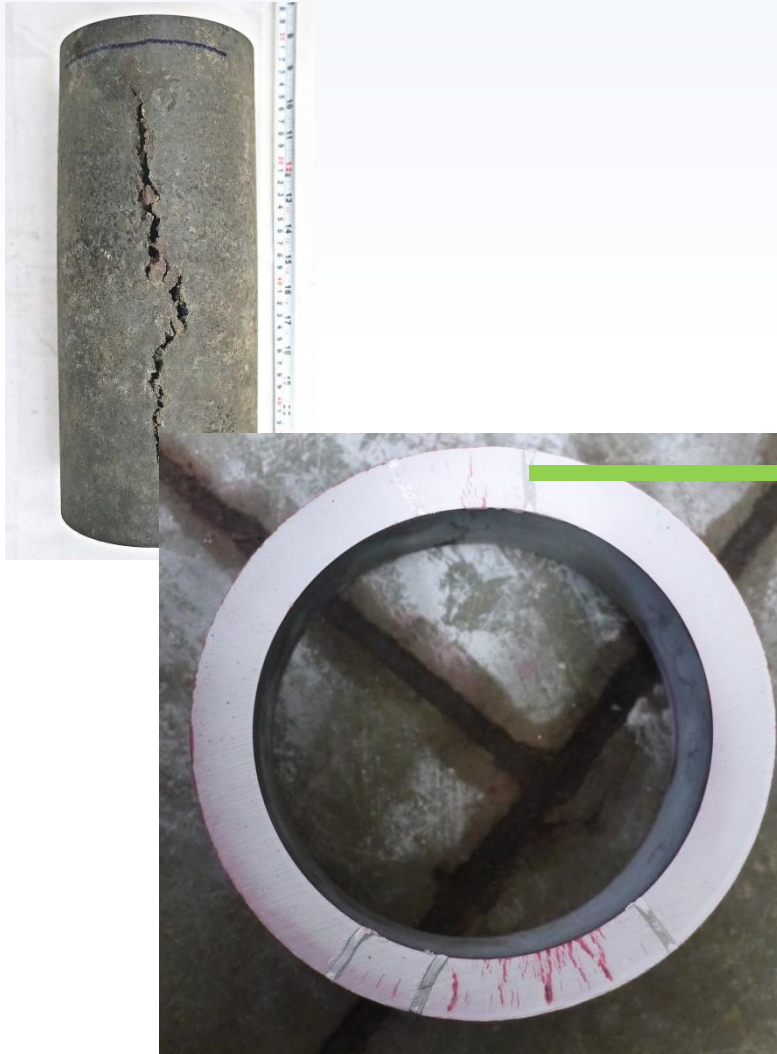
# Creep failure

Creep failures:

Occur as a result of continuous exposure of high temperature and stress.

Results in:

Unacceptable dimensional changes and/or creep rupture because of mid-wall creep-crack growth.

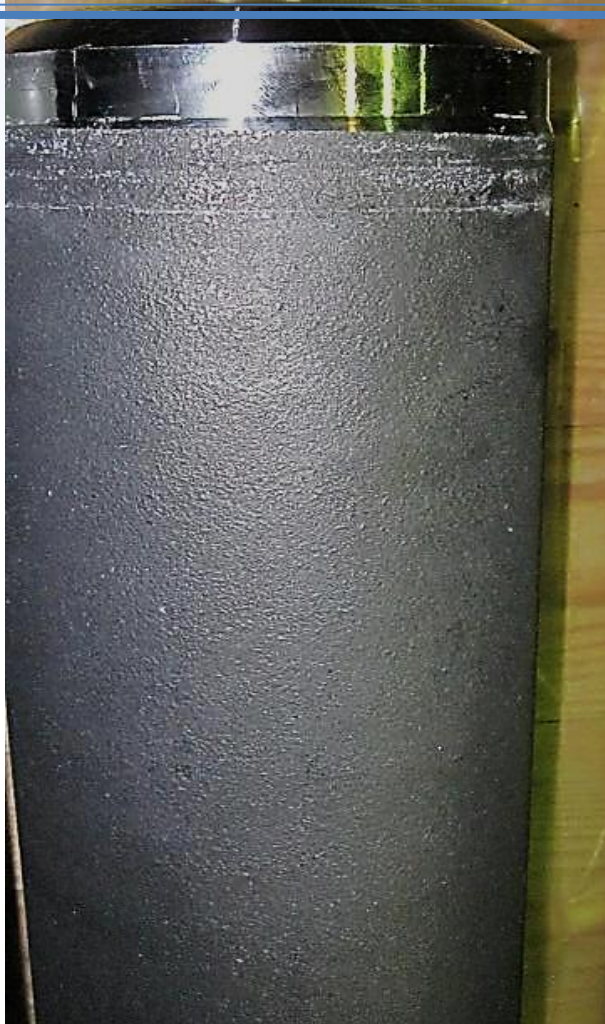
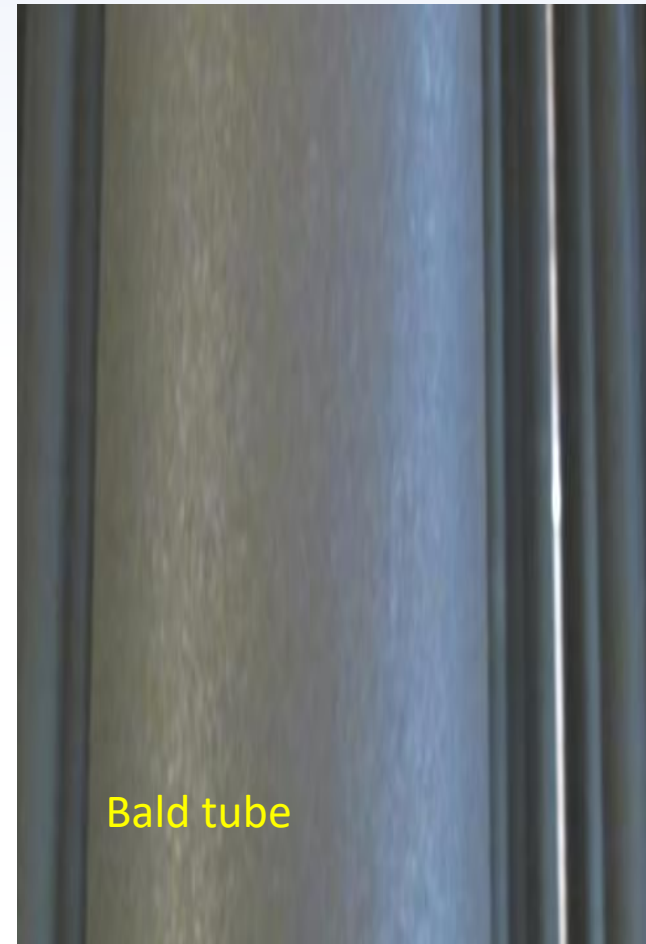
Bald tube

Comparison between two reformer tubes for showing baldness  
Result: Loss of effective tube metal thickness

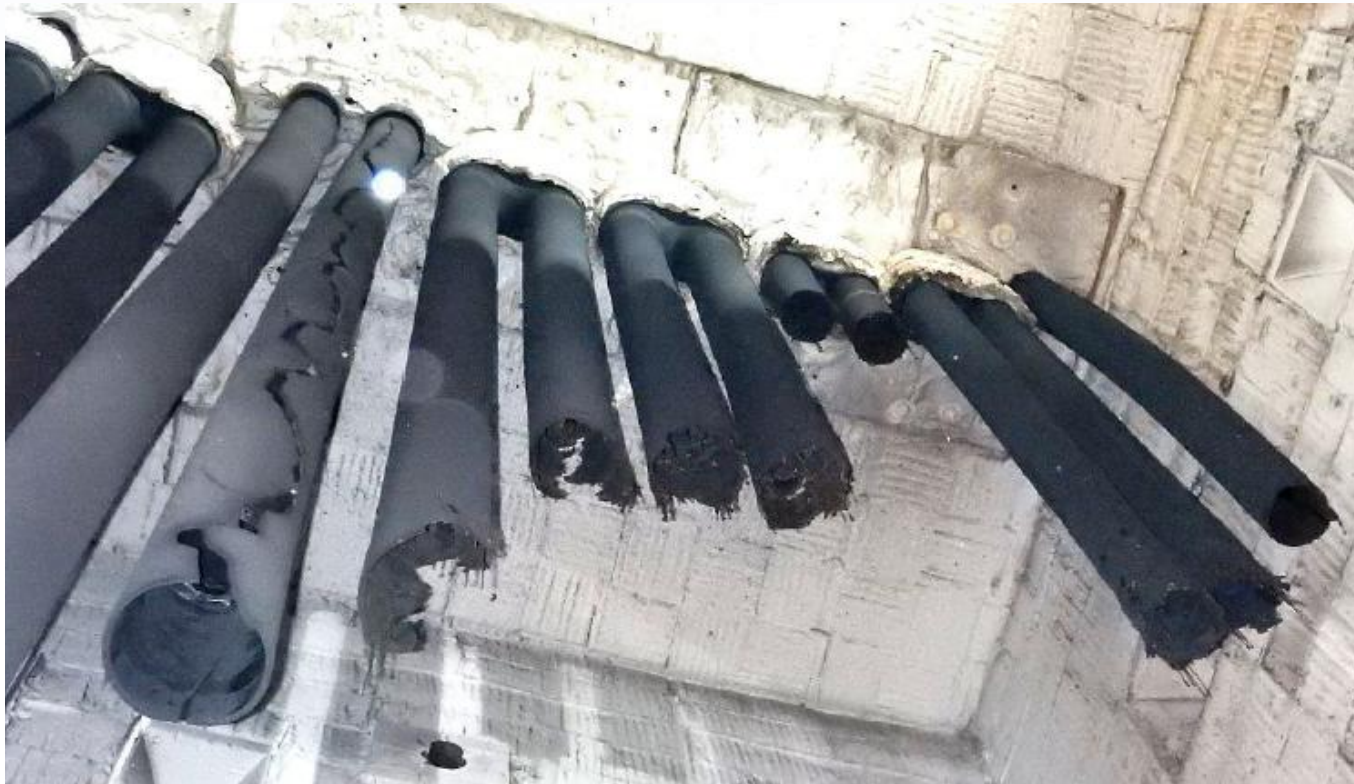
- Sudden change in temperature causes thermal shock that may result in abrupt, catastrophic failure of tubes.

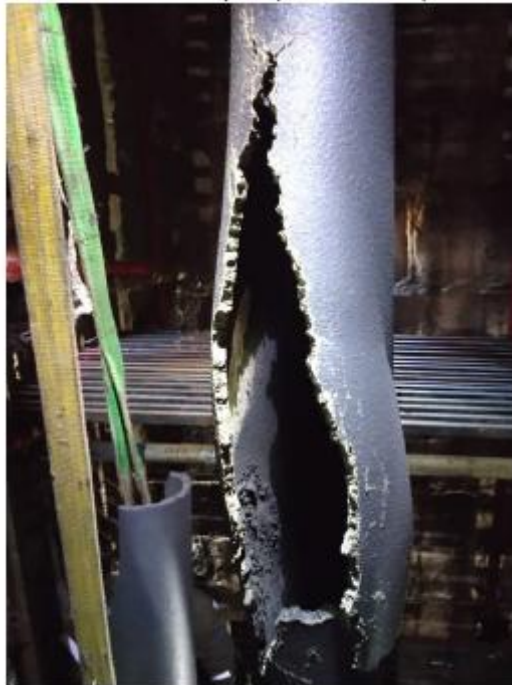
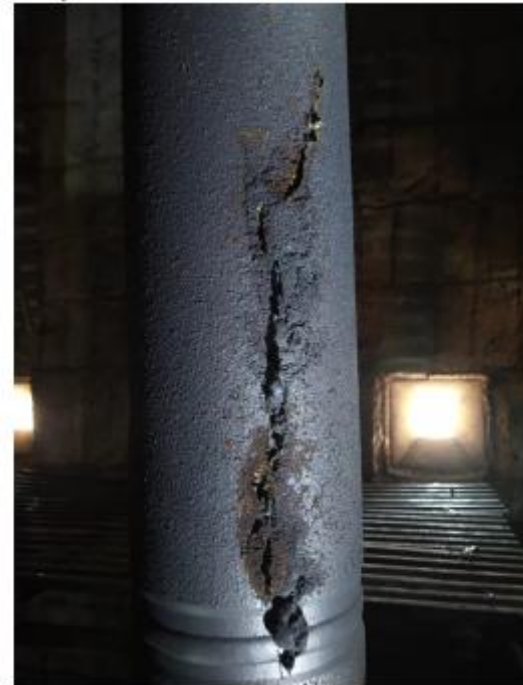
## ➤ *Direct flame impingement:*

- Mis-alignment of burners and / or their clogging creating disturbance in flue gas path can lead to direct flame impingement to the tubes.
- As a result, tubes tend to damage locally by overheating.

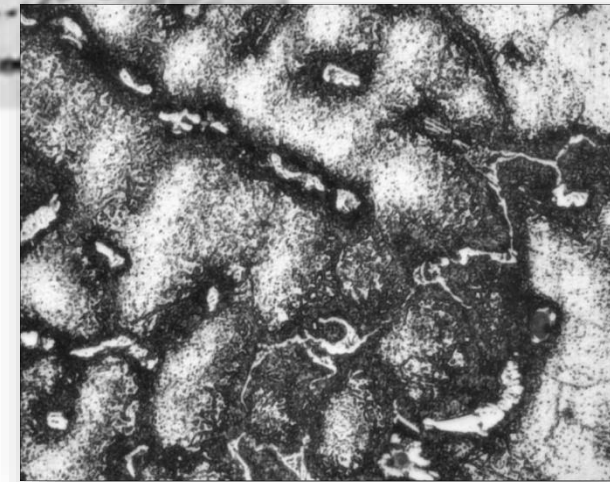
*Dendrite boundary*

*Secondary carbides*

*Creep voids*

TR Mode ultrasound wave attenuates by:

- Scattering at dendrite boundaries
- Secondary precipitates
- From creep damage, seen as formation of voids
- From interlinked voids (fissures) at mid-wall

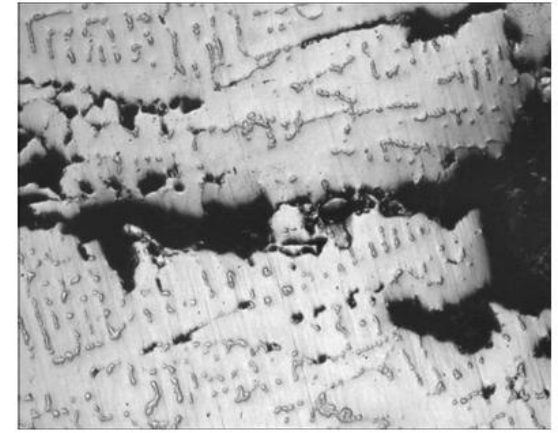
*Alloy HK40, Service exposed 29 years,*

Primary carbides at dendritic grain boundaries. Outer and inner edges show oxidation cracking. Aligned cavities are observed along primary carbide at core. The secondary carbides are nearly absent within the grains.

Sound attenuation measured is 56 to 62 dB
