# Integrated Approach for RLA of Reformer Tubes by NDT (ARTiS)

Ketan Upadhyaya, Paresh Haribhakti, Jaidev Patel and V K Bafna  
TCR Advanced, Vadodara and Mumbai, India  
[ketan@tcradvanced.com](mailto:ketan@tcradvanced.com)

**Keywords:** Reformer, Inspection, Creep, Fissures, RLA, ARTIS

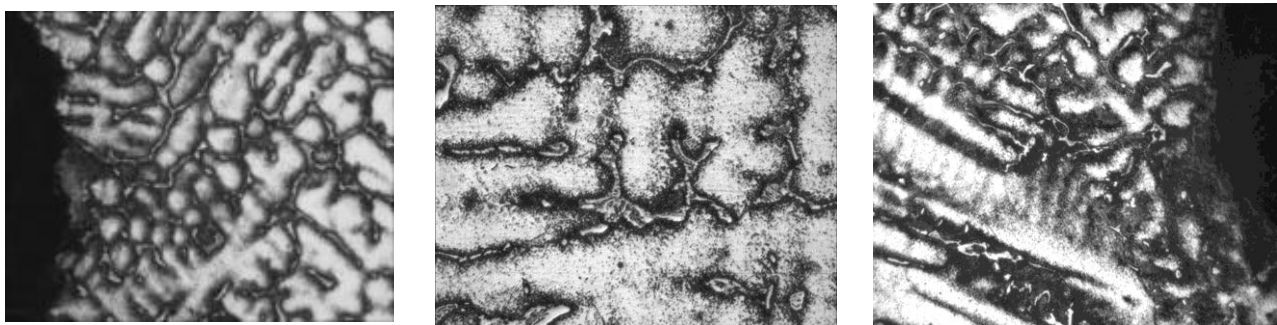
Figure 9 Alloy: ASTM A297 HP, Service exposed 29 years, 100mm away from rupture (in line of rupture), 100X, microstructures from OD (left), core and ID (right) show primary carbides at dendritic grain boundaries. OD and ID show intense tertiary creep cracking. Creep fissures are observed along primary carbide chain towards core. The secondary carbides area nearly absent within the grains. Sound attenuation measured is 56 to 58 dB
